TECHNICAL REPORT

NUMBER	TECHNICAL REPORT No. IT110030
DATE OF ISSUE	08 April 2011
PAGE	1 of 13

TEST SPECIMEN	Applicant's identification: <i>Protective covers for steel reinforcements</i> Delivery Note No.: 58023
TEST	Impact test. Test of penetration resistance. California Occupational Safety and Health Regulations (CAL/OSHA) Title 8, section 344.90
APPLICANT	AIJU- INSTITUTO TECNOLÓGICO DEL JUGUETE Avenida de la industria 23 03440 Ibi, Alicante
DATE/S OF TEST	03 February to 11 March 2011

This report summarises the impact test for determining penetration resistance of protective covers for the ends of steel reinforcements used in construction work. These protective covers are components for preventing or reducing damage to workers caused by accidental falls of different reinforced concrete items furnished with these devices and where the steel reinforcements protrude.

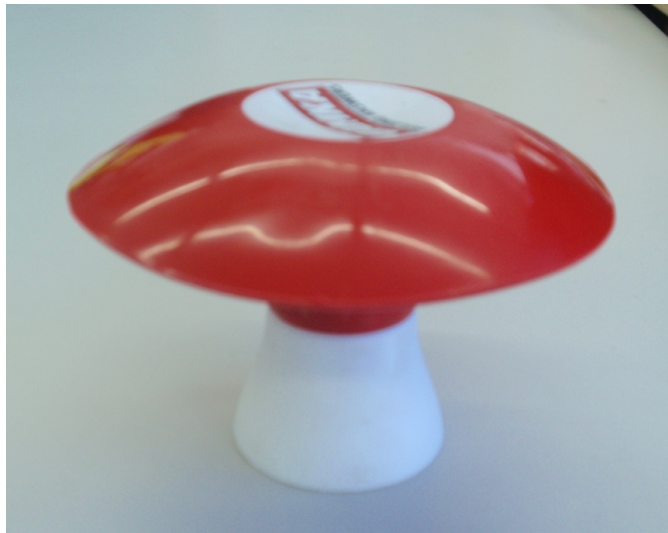
Photograph 1: Protection for reinforcement ends, object of the study.

- These are made of plastic material, composed of three different parts, manufactured from materials of different types, where the final composition is a composite which must provide the properties sought. The external casing of the protective cover is made of two parts manufactured in polypropylene. They are jointed together with a 2 mm thick steel plate between the white part and the coloured part, providing the resistance capacity against penetration.

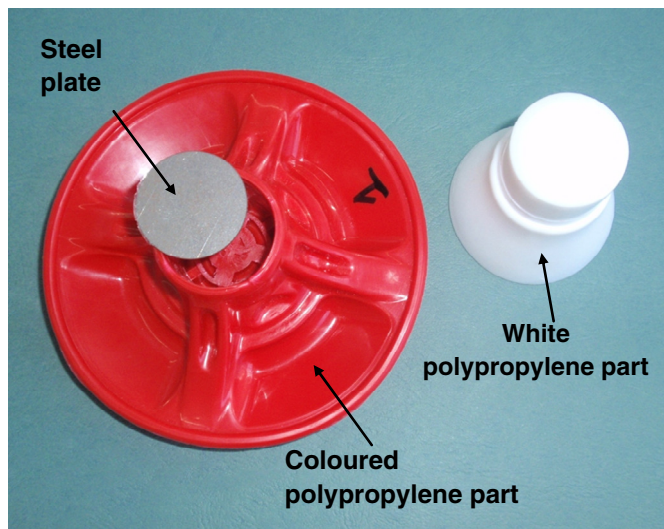
Photograph 2: Components making up the protective cover.

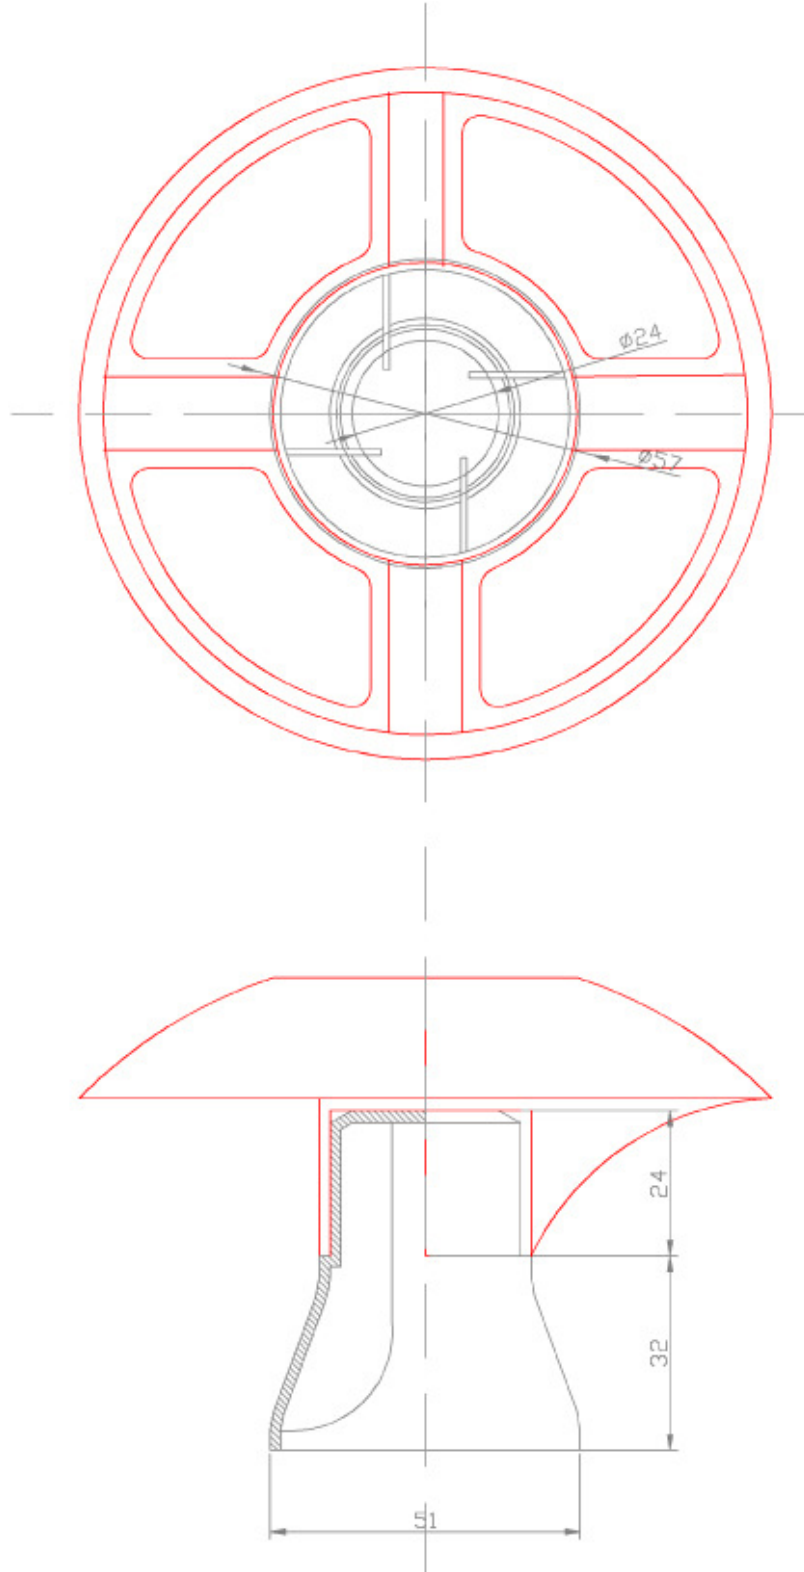
The device has a diameter of approximately 114 mm. The following diagram shows the geometrical features of the supplied protective covers under study.

Figure 1: Diagram showing the steel reinforcement end protective cover under study.

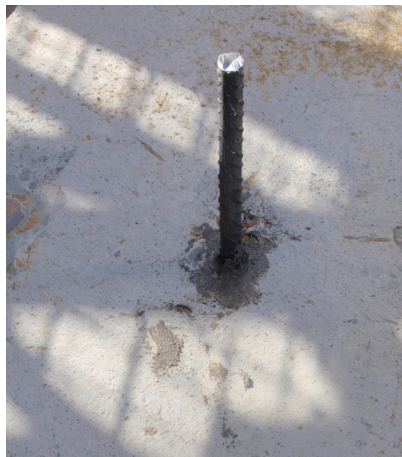
Photograph 3: Arrangement of the bar on the test supporting structure.

- **Installation and mounting of the steel bar (according to section 344.90, section e.1.B):** the test must be performed on a bar of size #4 (bars with nominal diameter of 12.7 mm). In this case, the test was performed on bars of **12 mm** diameter. As a supporting structure for mounting the steel bar, a prefabricated concrete beam was used. The bar was installed on it with an exposed length (above the beam) of 150 mm.

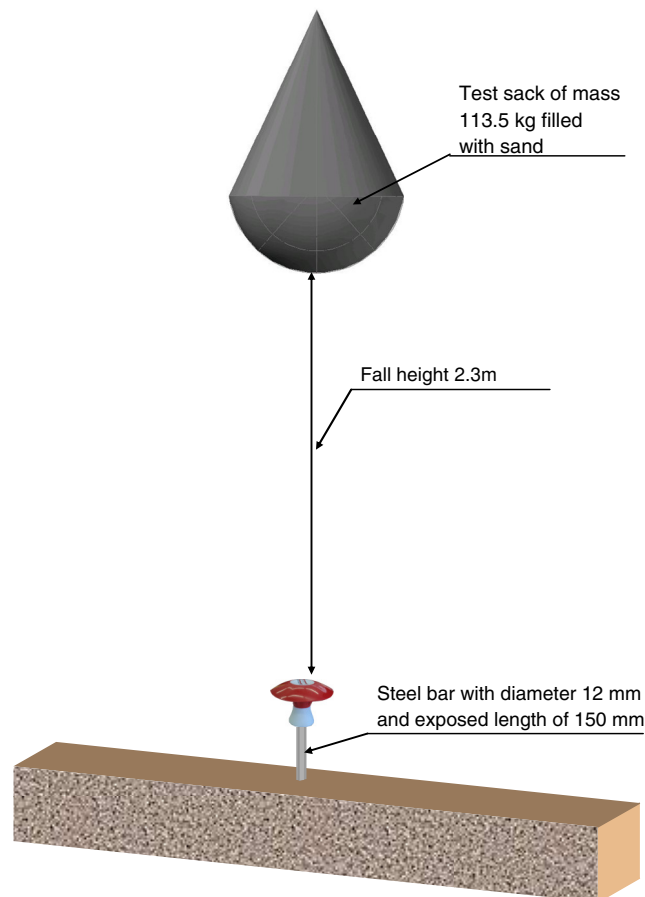
The test method is based on the free fall from a height of 2.3 m of a test mass of 113.4 kg that is released by means of a rapid release mechanism, as indicated in the following diagram.

Figure 1: Test schema.

To perform the evaluation of the protective cover against the resistance to penetration requirements indicated in section 344.90 of CAL/OSHA, three impacts were performed with a kinetic energy of approximately 2.5 kJ.

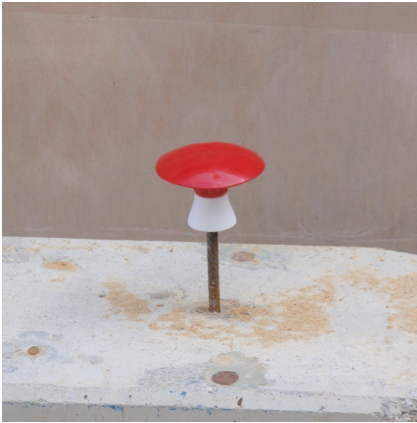
Photograph 4: Initial arrangement of the test for the first impact. Placement of the protective cover at right angles on the bar.

- The first impact was performed with the protective cover installed perfectly square to the bar.
- The second and third impacts were performed installing the device at the maximum allowed angle with respect to the bar.

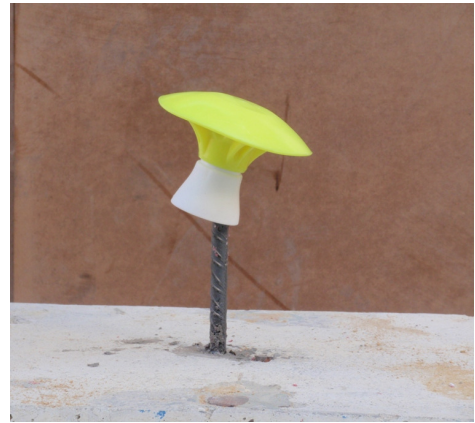
Photograph 5: Initial arrangement of the test for the second and third impact. Placement of the protective device with the maximum angle on the bar.

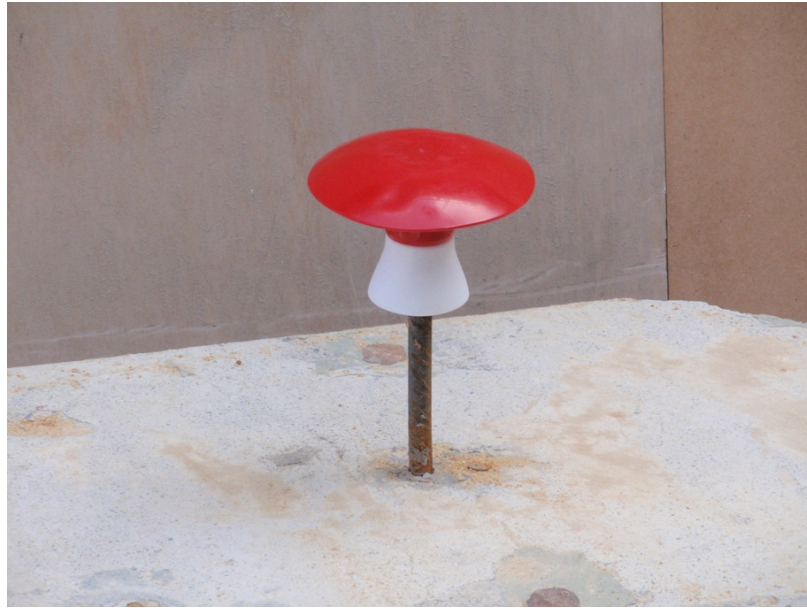
Photograph 6: Initial arrangement of the protective cover for the first impact.

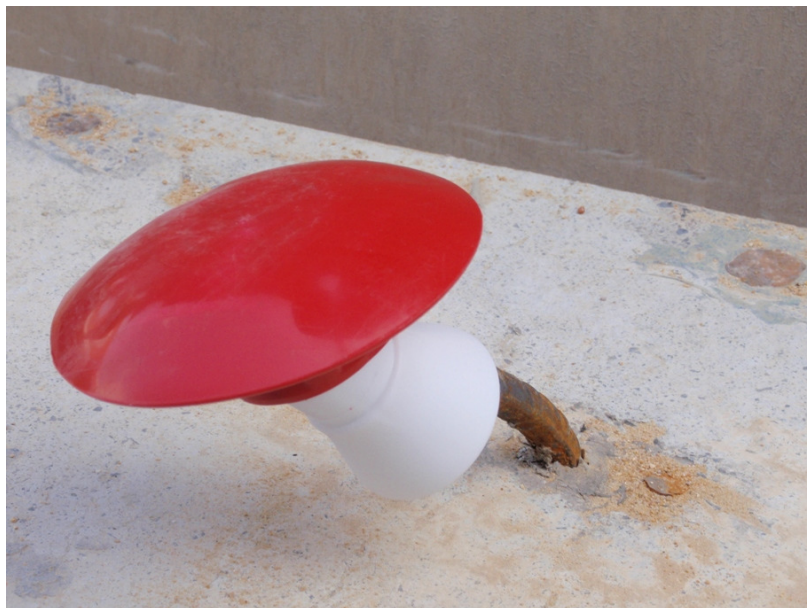
Photograph 7: Arrangement of the protective device after the first impact. No penetration of the protective cover by the bar occurred.

- **The protective device supports the impact made without penetration.**
- Partial breaks were observed in the internal steel reinforcement and in the white part.

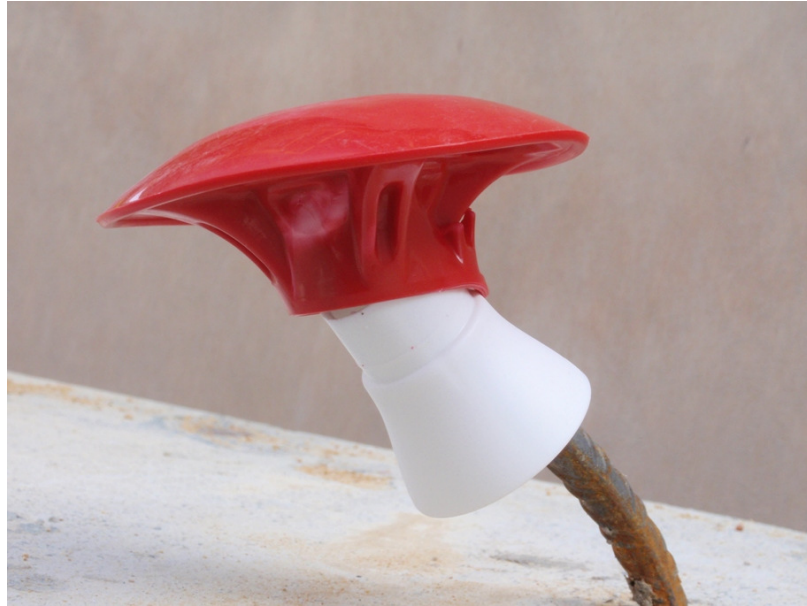
Photograph 8: Deformations and partial breaks caused in the mushroom by the impact.

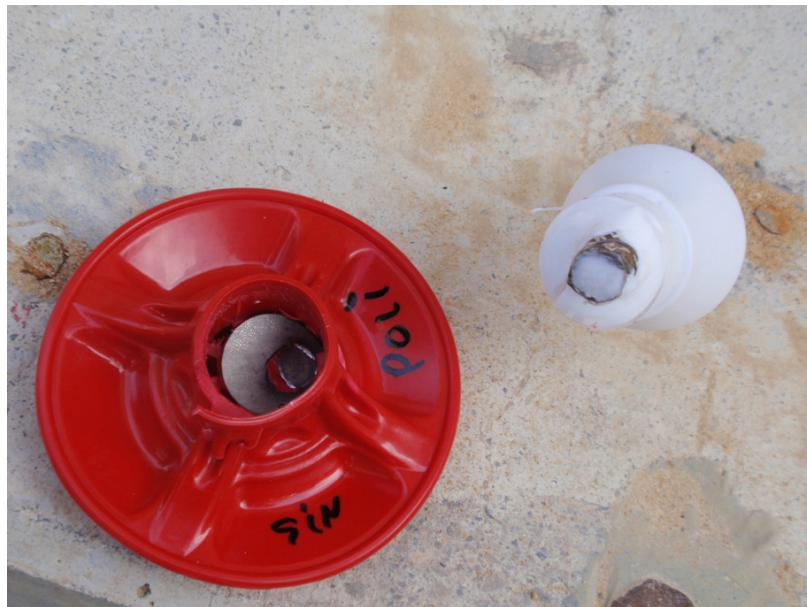
Photograph 9: Deformations and partial breaks caused inside the component.

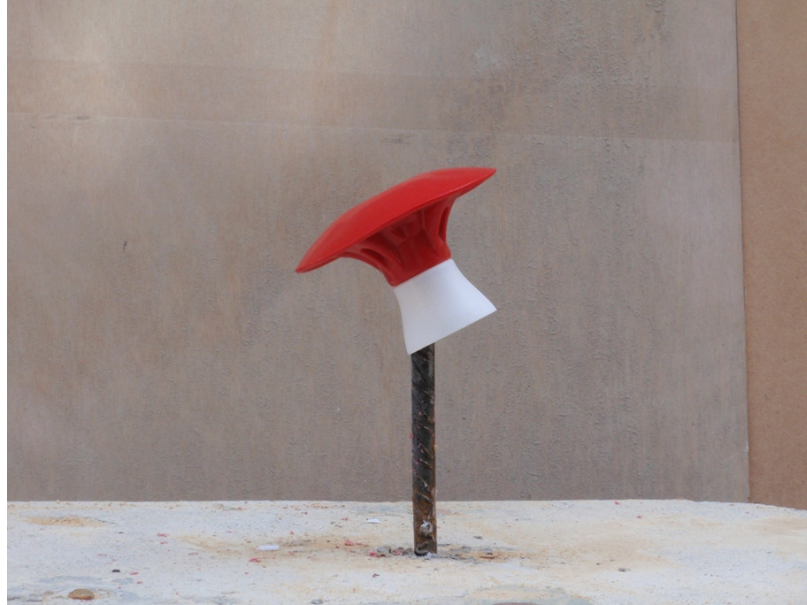
Photograph 10: Initial arrangement of the protective cover on the bar for performing the second impact.

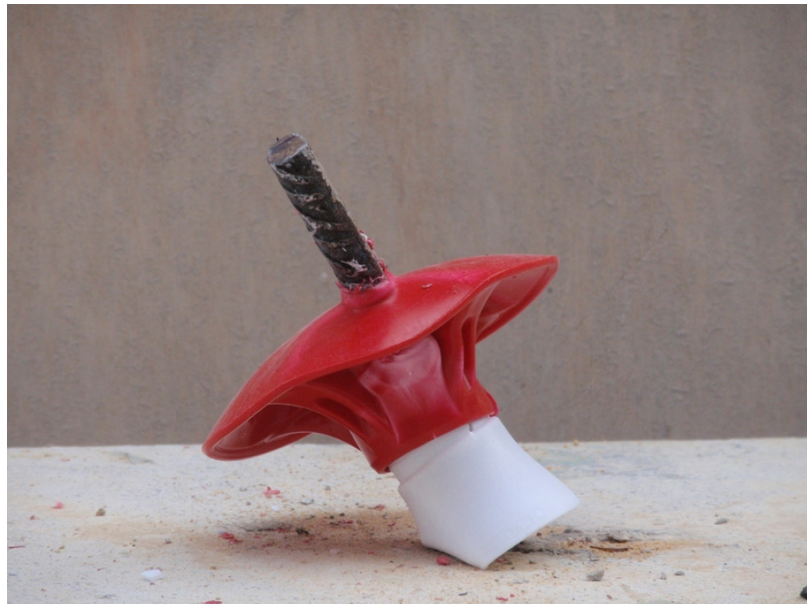
Photograph 11: State of the protective cover after performing the second impact. The protective cover was penetrated.

- **The protective device was penetrated by the steel bar.**
- Placement of the protective device at the maximum angle results in the bar penetrating through the zone where the steel reinforcement does not act, penetrating both the white part and the coloured part.
